*Scientific paper*

## Self-Healing Capability of Fibre Reinforced Cementitious Composites

Daisuke Homma<sup>1</sup>, Hirozo Mihashi<sup>2</sup> and Tomoya Nishiwaki<sup>3</sup>

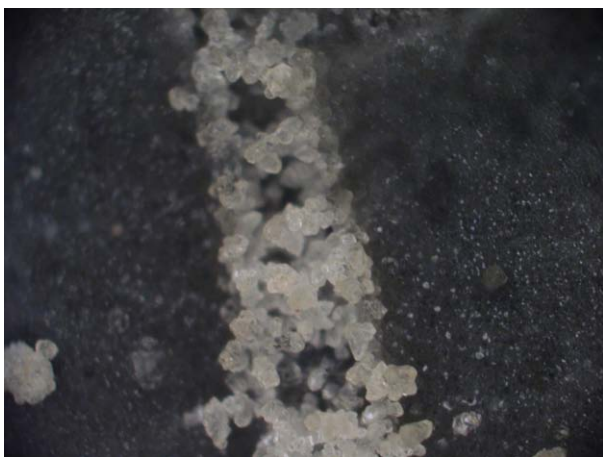
Fig. 4 Example of crystallization products.

The formation of crystallization products (**Fig. 4**) that might be the source of self-healing was monitored just after the tension test and at the end of 3, 14, and 28 days after water permeability test. Additionally the thickness of the crystallization products on the crack surface was also measured by means of a digital microscope. **Table 4** shows the typical crack surface photographs in FRCC (PE), FRCC (SC), and HFRCC at the elapsed time of 0 day (immediately after tension test and before immersion in water), at 3 days, 14 days and 28 days.

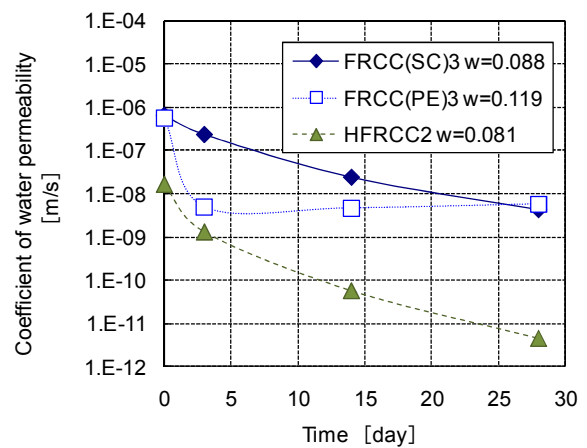
Fig. 11 Influence of time dependence of water permeability coefficient due to type of FRCC.

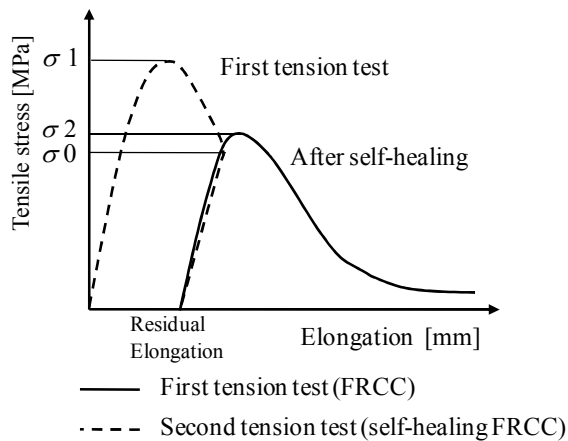
Fig. 14 Schematic of the relationship between tensile stress and tensile elongation of FRCC.

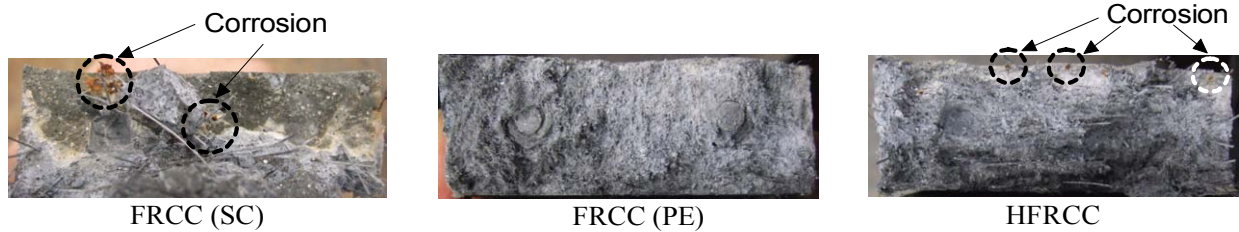
Fig. 16 Comparison of crack surface after second tension test.

**Figure 16** shows a comparison of crack surfaces after the second tension test. By observing the crack surface, it was confirmed that corrosion of steel cord was observed not only on the surface of specimens with crack but also on the surface of inside of the crack in case of FRCC (SC). In case of HFRCC, however, the corroded steel fibre was observed only on the surface of the specimen (i.e. the external surface of the crack) but it was not observed on the internal surface of the crack. This could be because in HFRCC a lot of calcium carbonate crystals not only covered the surface of the crack but also attached to the matrix around steel cord fibres. It corresponds to the increase of tensile strength of HFRCC after the self-healing.
